Technical Report 574

**HARDWARE AND PERFORMANCE EVALUATION:
TETHERED FLOAT BREAKWATER
NEAR-SHORE OCEAN MODEL**

JD Clinkenbeard

July 1980

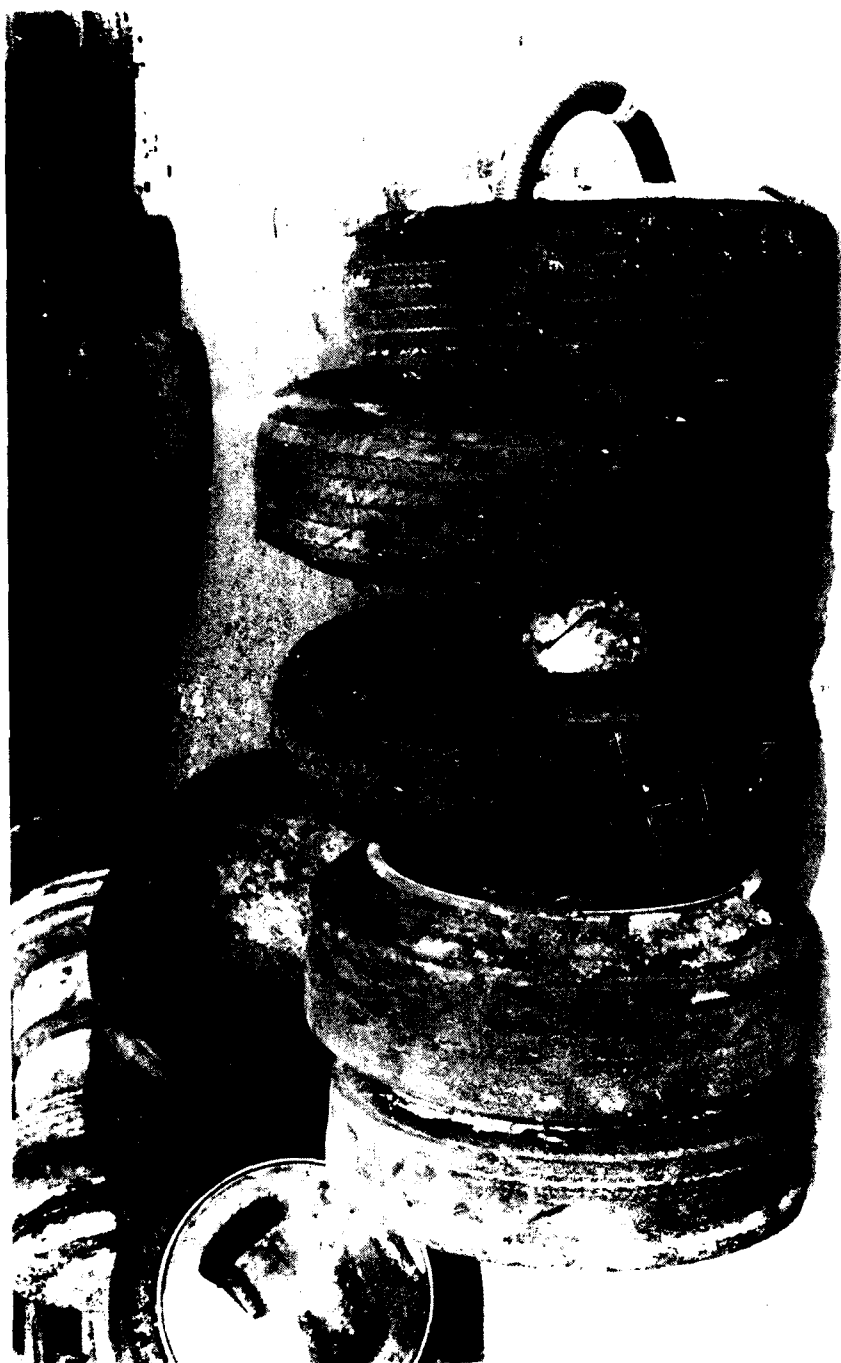
Figure 15. Recovered float showing tire separation.

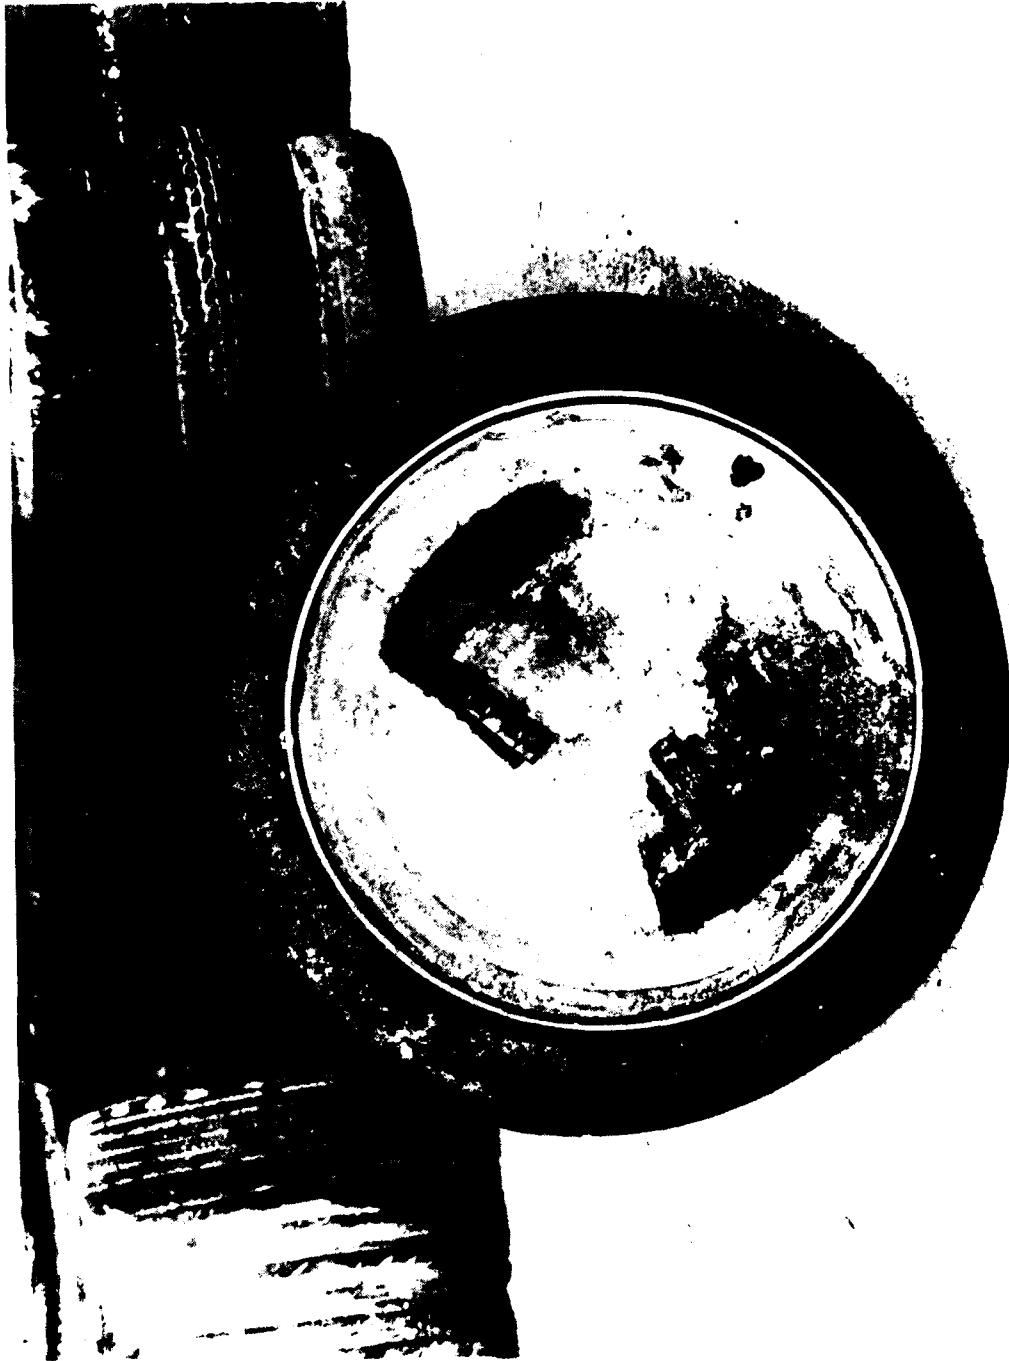
Figure 18. Void caused by sawing action of reinforcing rod.

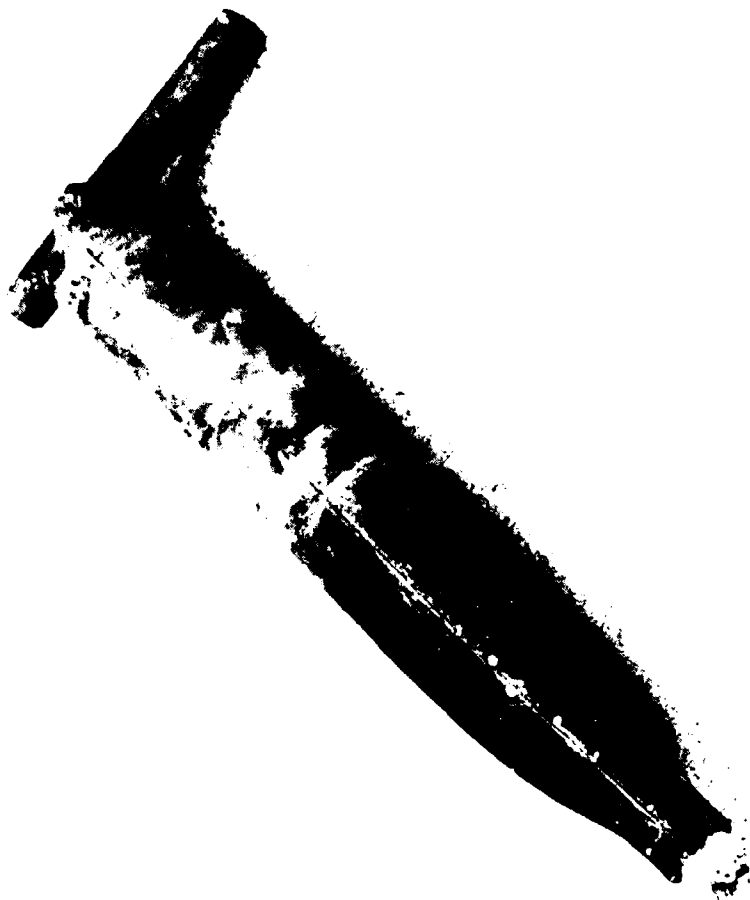
The majority of the tether separations (92% of the original units recovered) occurred at the same location in the line—a discontinuity 1/2 to 1 inch above the boot. This change in tether cross-section resulted from terminating the eye splice at the lower end of the tether. Figures 22 and 23 illustrate this type of failure. Note that all line fibers are approximately the same length, indicating a possible cutting action.

A few samples were removed from the test site and inspected in the laboratory. A video recording was made of actual in-water motion of a typical tether assembly. Upon analysis of the tape and sections of recovered tethers, the cause of failure was determined to be a combination of nonuniform axial loading and internal abrasion of the fibers.

Figure 22. Termination boot after tether failure.

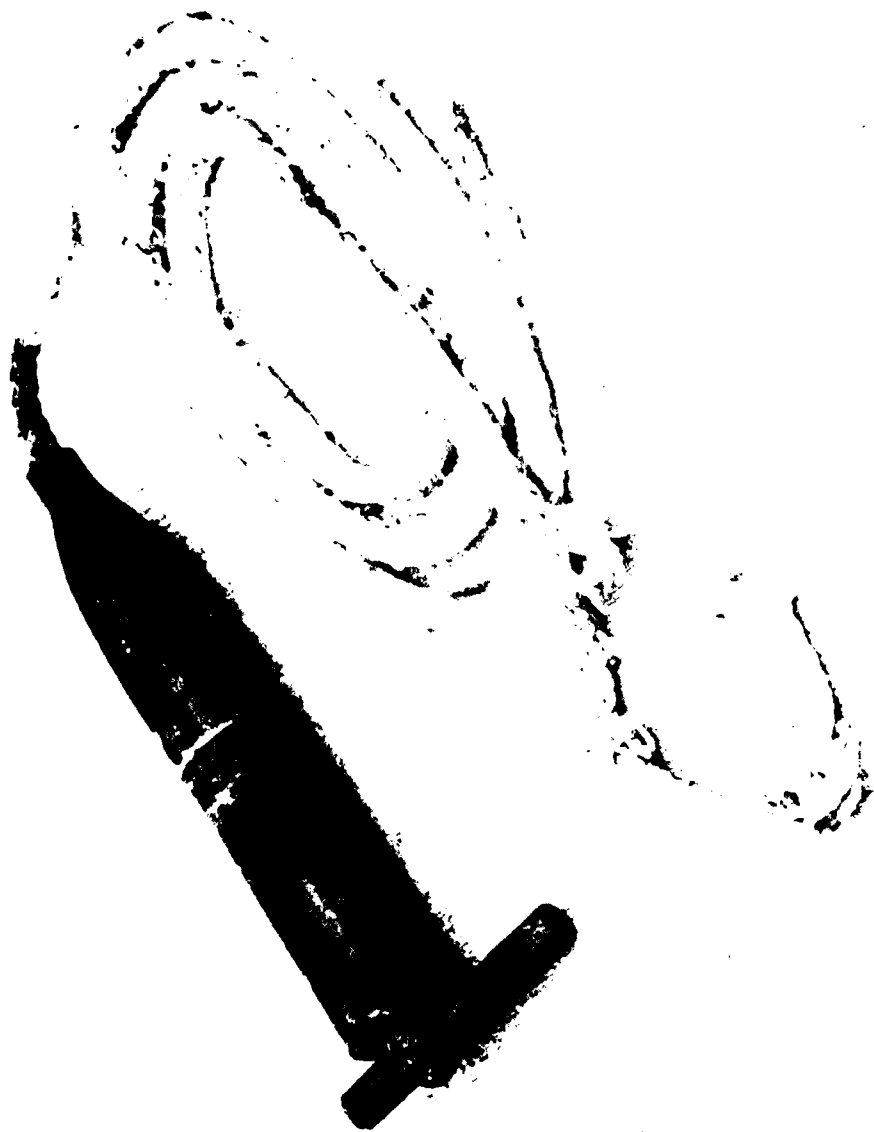
Two boots cracked at the top of the tether socket (figure 25). This resulted from insufficient radius on the inner edge of the tether socket which caused concentrated bending stress.

Figure 25. Boot cracked at top of tether socket.

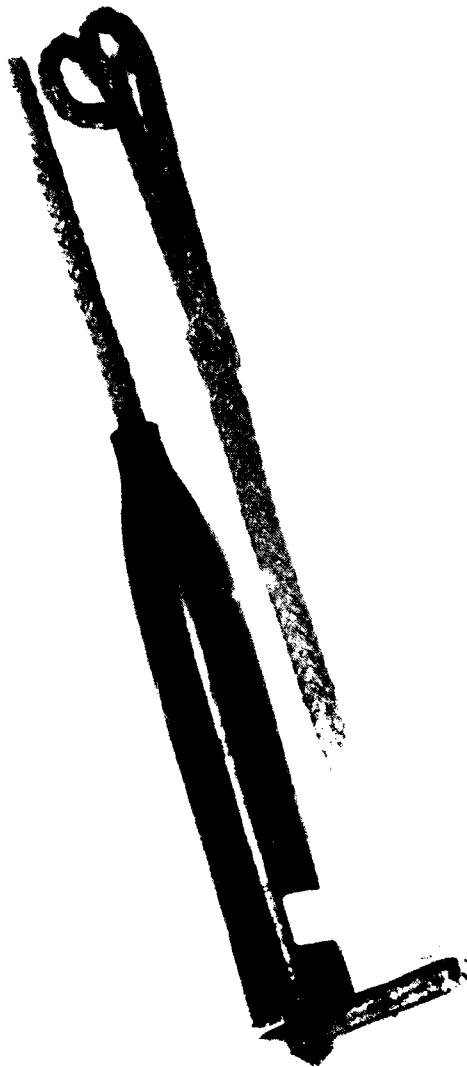
Figure 26. Modified tether assembly (Type B).

In an effort to substantially reduce the failure rate, the tether design was modified. The basic configuration remained unchanged. However, a low modulus elastomer was used to impregnate and encapsulate the line at the buried end of the splice to prevent entrance of particulate matter into the line core, and minimize fiber-to-fiber abrasion during cyclic axial loading. During 12-14 December 1978, 36 tethers were replaced in the field with two modified versions. Type A was original construction, but with the area above the boot impregnated with polyurethane for a length of 7 inches. The end of the eye splice was lengthened in Type B to extend 6 inches above the boot to further separate the line discontinuity from the molded termination; the tether was impregnated as in Type A. Modifications to tether assemblies (Types A and B) also included lengthening and impregnating the upper eye splice to guard against abrasion at the bail. Figure 26 shows a modified tether assembly (Type B). These proved to be more durable than the former design. Internal abrasion at the lower termination is no longer considered a problem. During the Ocean Model refurbishment in late May 1979, Type B assemblies were used exclusively. A new unit is shown installed in figure 27.
